OPAL TOWER INVESTIGATION INTERIM REPORT

**Independent Advice to NSW Minister for Planning and
Housing**

14 January 2019

OPAL TOWER INVESTIGATION – INTERIM REPORT

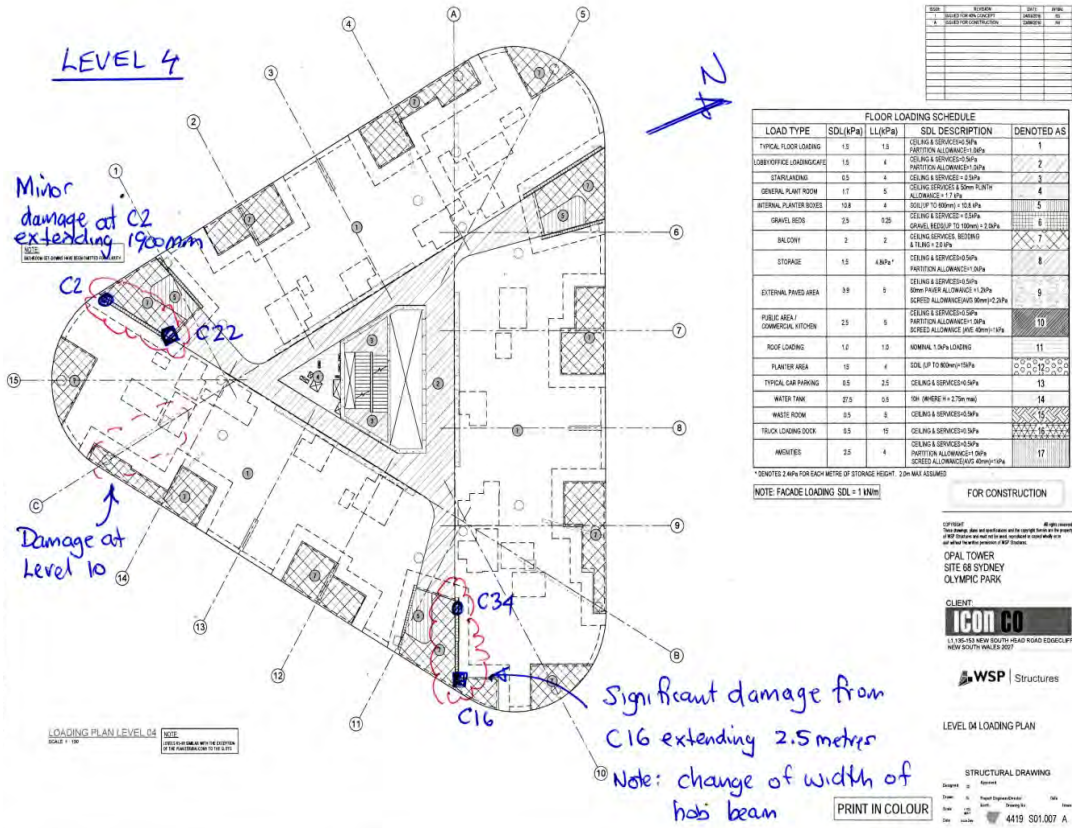
2. A hob beam spanning between columns C16 and C34 (along grid line A shown in Figure 3) – see Figure 10. This also appears to be major damage.
3. A hob beam spanning between columns C2 and C22 (along grid line B show in Figure 3). These cracks could be considered minor *at this stage*.
4. Cracking was also observed in the floor plate between Levels 3 and 4 – see Figure 11.

Figure 3. Plan view indicating locations of damage observed on Level 4

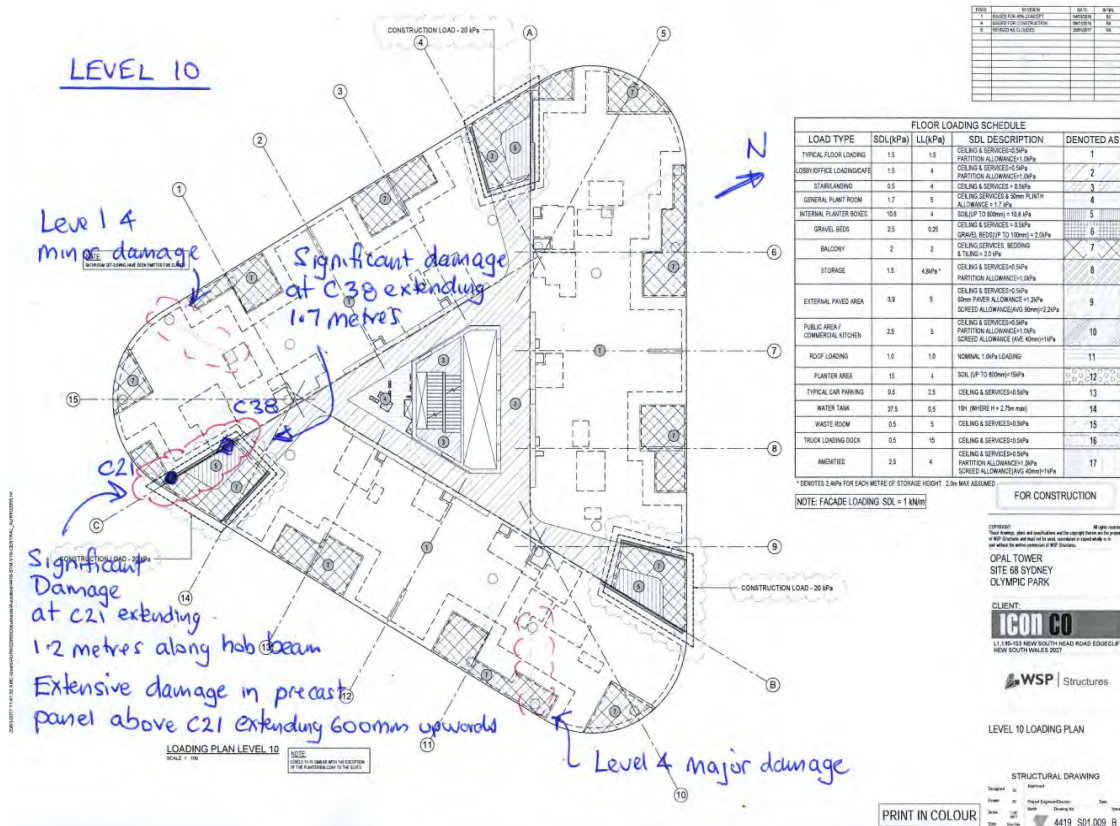
1. A hob beam spanning between columns C21 and C38 (along grid line C shown in Figure 4) and the Panel A resting on it – see Figures 5 to 8. Cracking was also

Figure 4. Plan view indicating locations of damage observed on Level 10

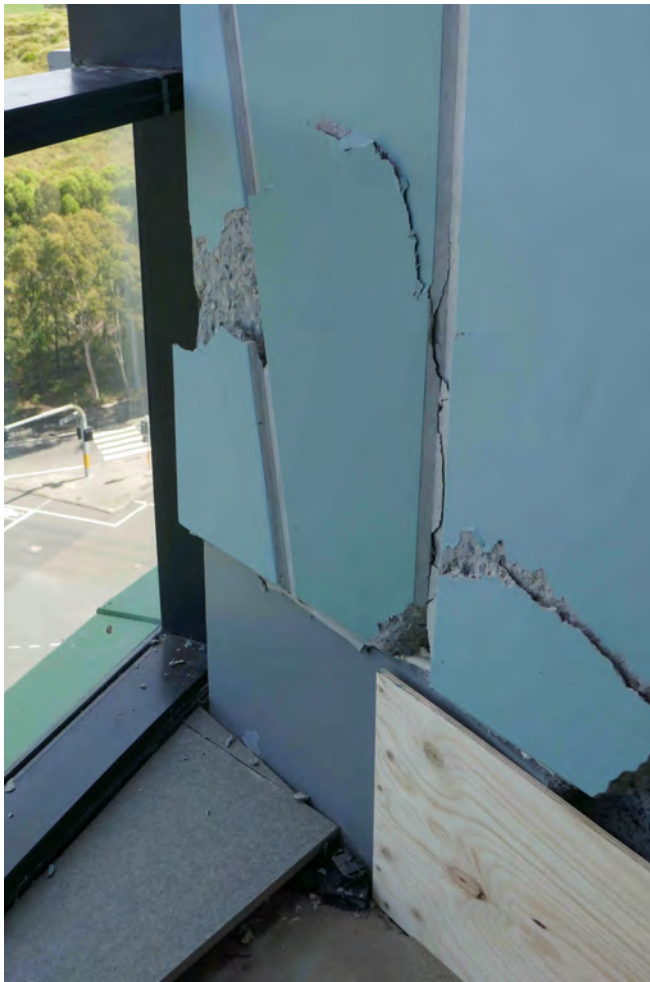
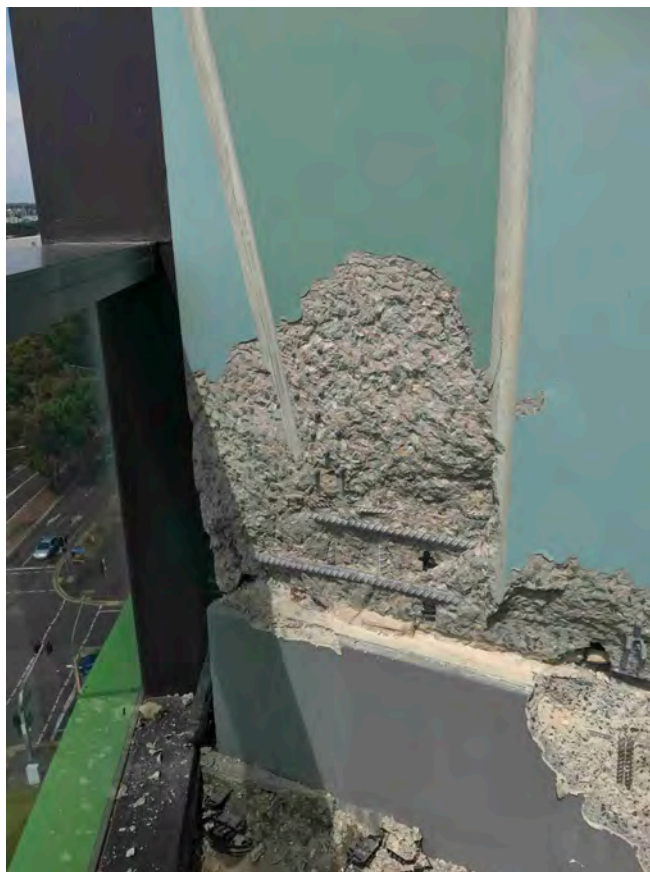
observed in the floor plate adjacent to column C21 – see Figure 9. This was the damage observed on Christmas Eve and is considered to be major damage.

From the security camera footage referred to previously, we observed cracking in the bottom corners of the bottom panel (Panel A) on Level 10. The time stamp on this video recording indicated that the cracking of the panel commenced at approximately 2.16 pm on Monday 24 December 2018 and continued for approximately 8 seconds.

Figure 5. Damaged precast Panel A at Level 10 above column C21, before (top) and after (bottom) broken section of concrete removed.

WSP has briefed us on the structural principles behind their proposal for permanent repair of the damage observed on Levels 4 and 10 and strengthening of the associated structural members, viz., the hob beam and lowest panel at these locations. We understand that WSP is proposing that these rectification works should be carried out as a three-stage process.

It is our opinion that the structural *principles* behind the WSP proposal for rectification are sound. In particular, the defective structural members will be strengthened by the proposed measures. However, we have not received details of a structural analysis of

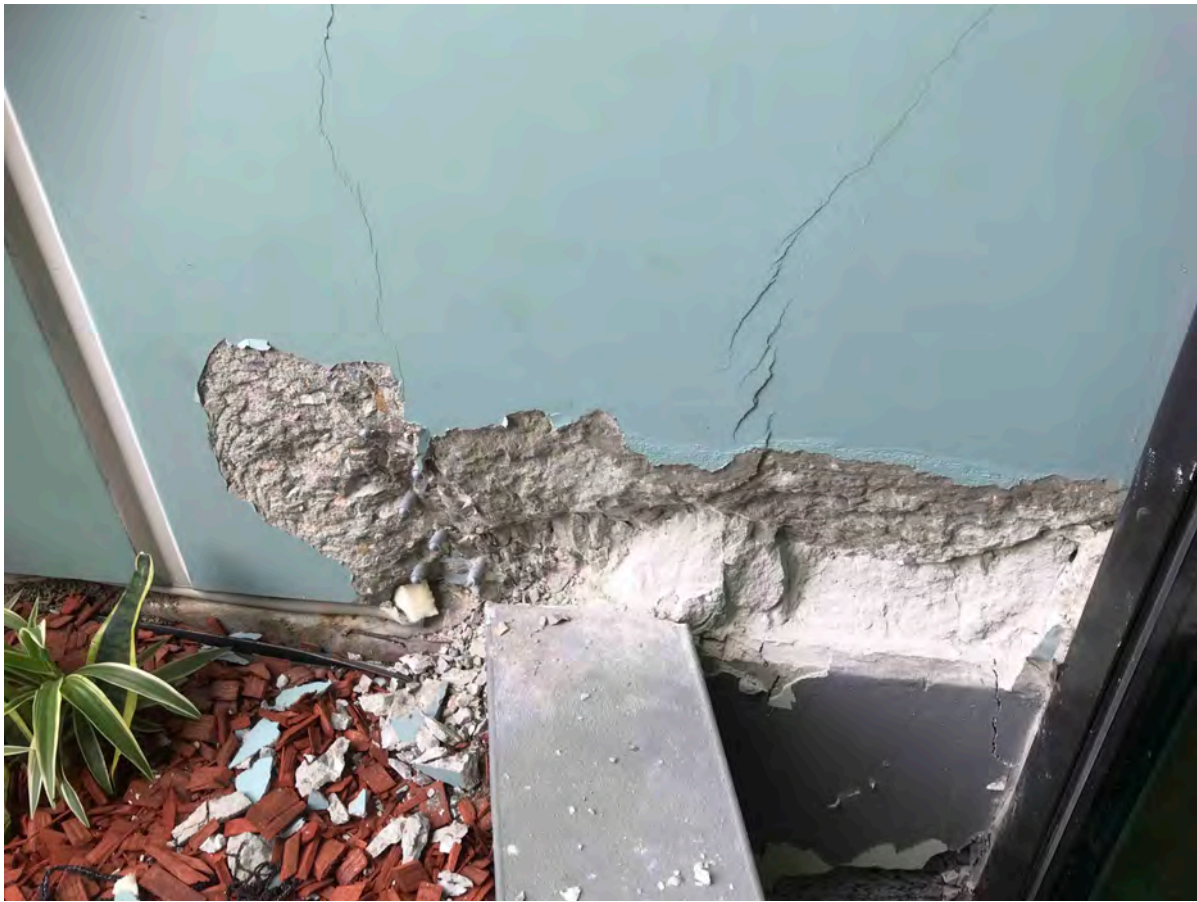
Preliminary consideration of the bearing capacities of the hob beam at the locations of the connection of the beams with columns C21 and C38 on Level 10 and with columns C16 and C34 on Level 4 indicate factors of safety lower than required by Standards. To date, we are still awaiting further details of design analyses to further consider this factor.

Figure 6. Damaged precast Panel A at Level 10 above column C38, after some broken sections of concrete removed.

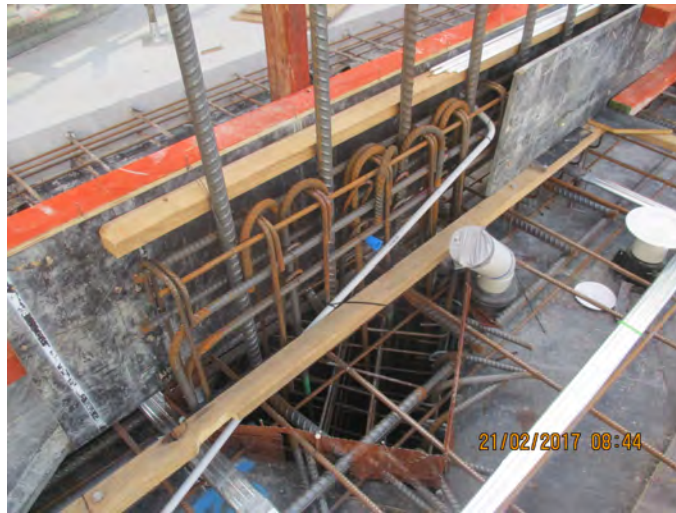
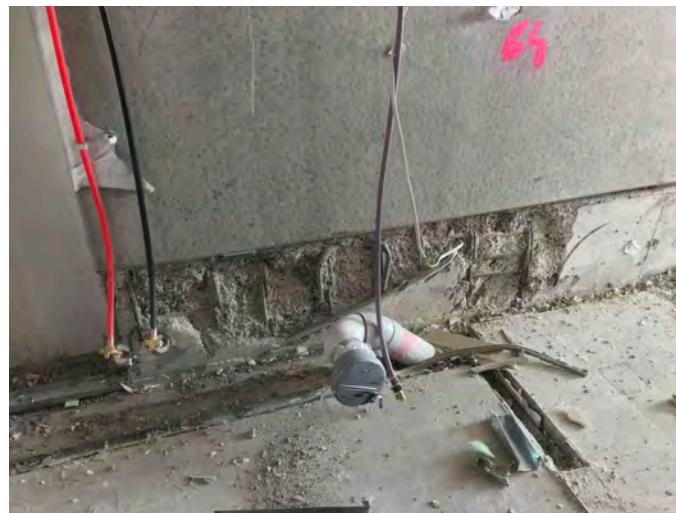
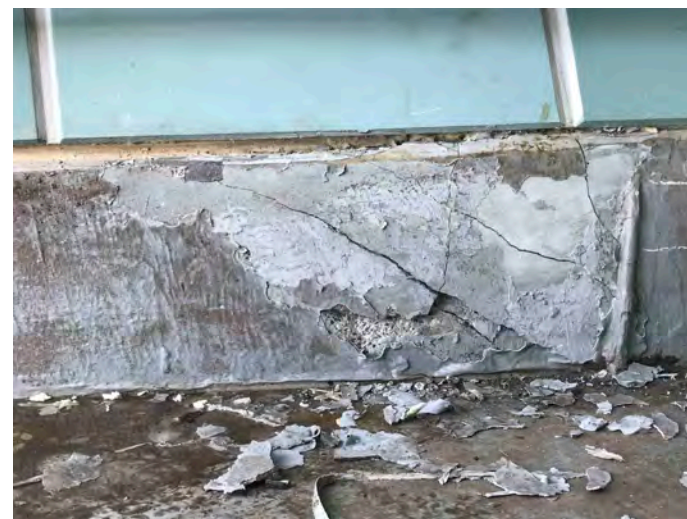
- (a) Grouting: design drawings indicate that full grout coverage was expected between the panel and the hob beam. However, during construction only the inner surfaces of approximately 110mm width appear to have been grouted, leading to an eccentric bearing load on the hob beam on Level 10. It should also be noted that approved shop drawings show the grout extending over only the inner portion of the hob beam to panel connection;

- (b) Location of reinforcing steel in the vicinity of the connection between the hob beam and columns C21 and C38 on Level 10, in particular, inadequate cover concrete due to encroachment of discontinued (anchored) column bars into the cover zone, and the placement of an electrical conduit within the cover zone in this area;

Figure 7. Photographs of the hob beam in the vicinity of column 38 at level 10, prior to pouring concrete (top photo), inside the building on 8 January 2019 after cracked concrete cover removed (middle), and outside on 8 January 2019 after the garden and waterproof covering removed (bottom). Note the positioning of the reinforcing bars, the encroachment of the column bars into the cover zone, the lack of anchorage of some horizontal bars, and the encroachment of a conduit into the concrete cover zone. The vertical dowel bars that engage with the precast concrete panels can also be seen in the top photograph.

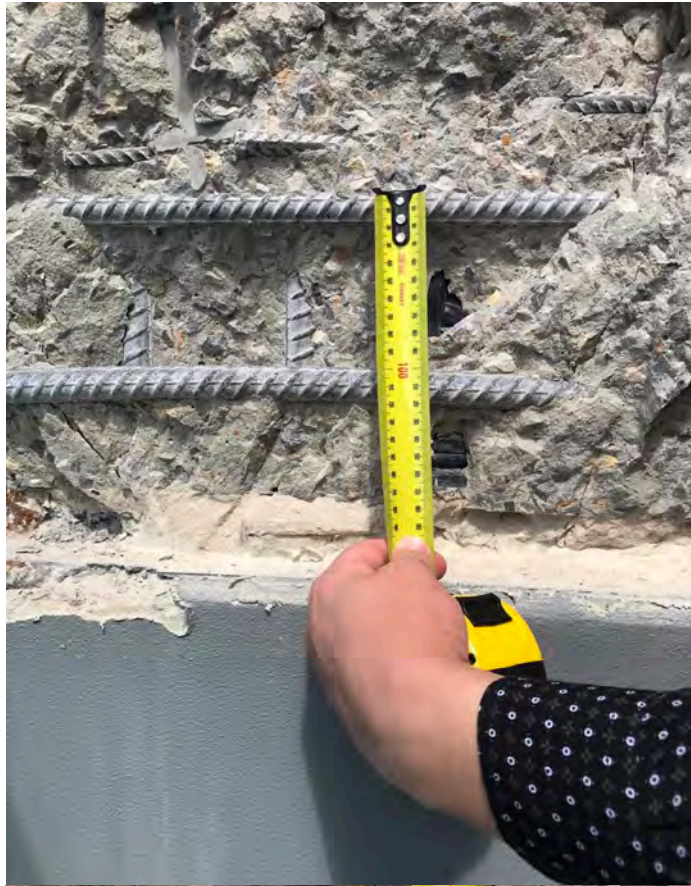
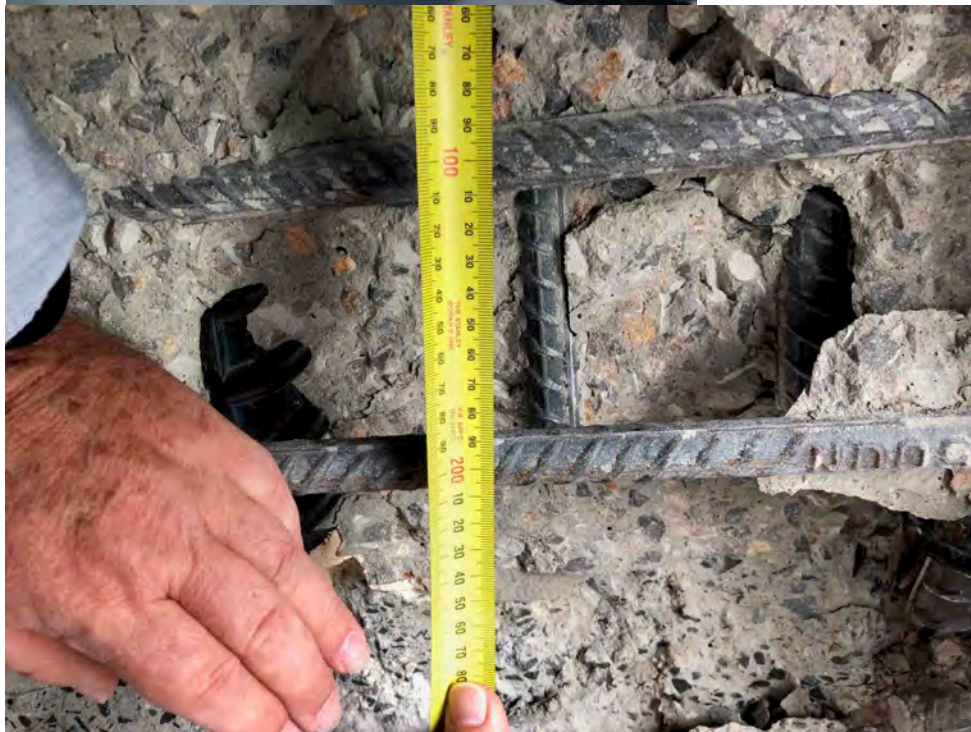
- (e) Inadequate tensile capacity in the horizontal direction in the bottom region of Panel A that rests on the hob beam spanning columns C21 and C38. There is compelling evidence indicating that the wrong size reinforcing bars were placed in this area during manufacture of this particular panel – 20 mm diameter bars were used instead of 28 mm diameter bars (see Figure 8).

Figure 8. Photographs of the outside (top) and inside (bottom) of panel A at Level 10 just above hob beam adjacent to column 21, indicating N20 reinforcing bars at 100 mm centres in the lower portion of the precast panel. Note the exposed grout between panel A and the hob beam and the black plastic sheath for the joining dowel (top photo, right of tape measure).

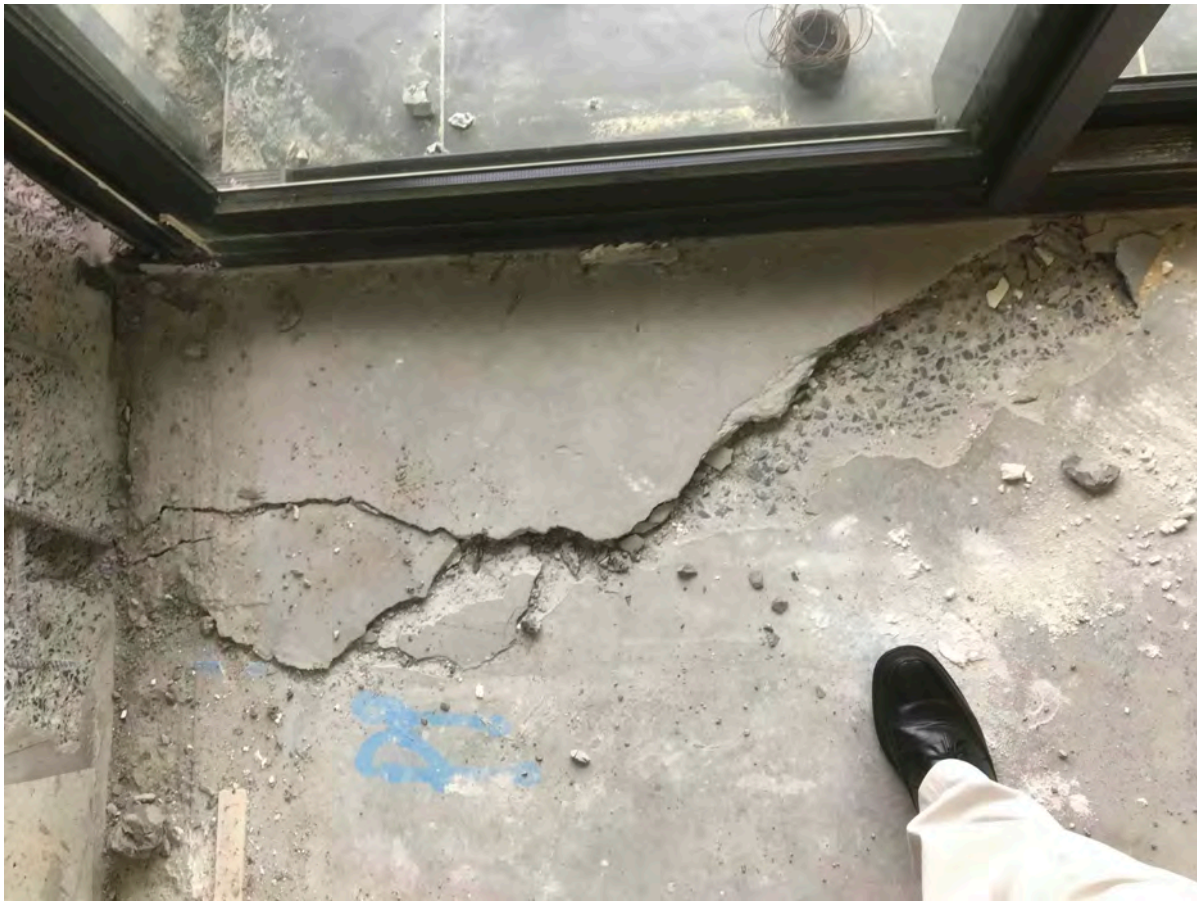
Figure 9. Photographs of the damaged floor slab adjacent to column C21 on Level 10.

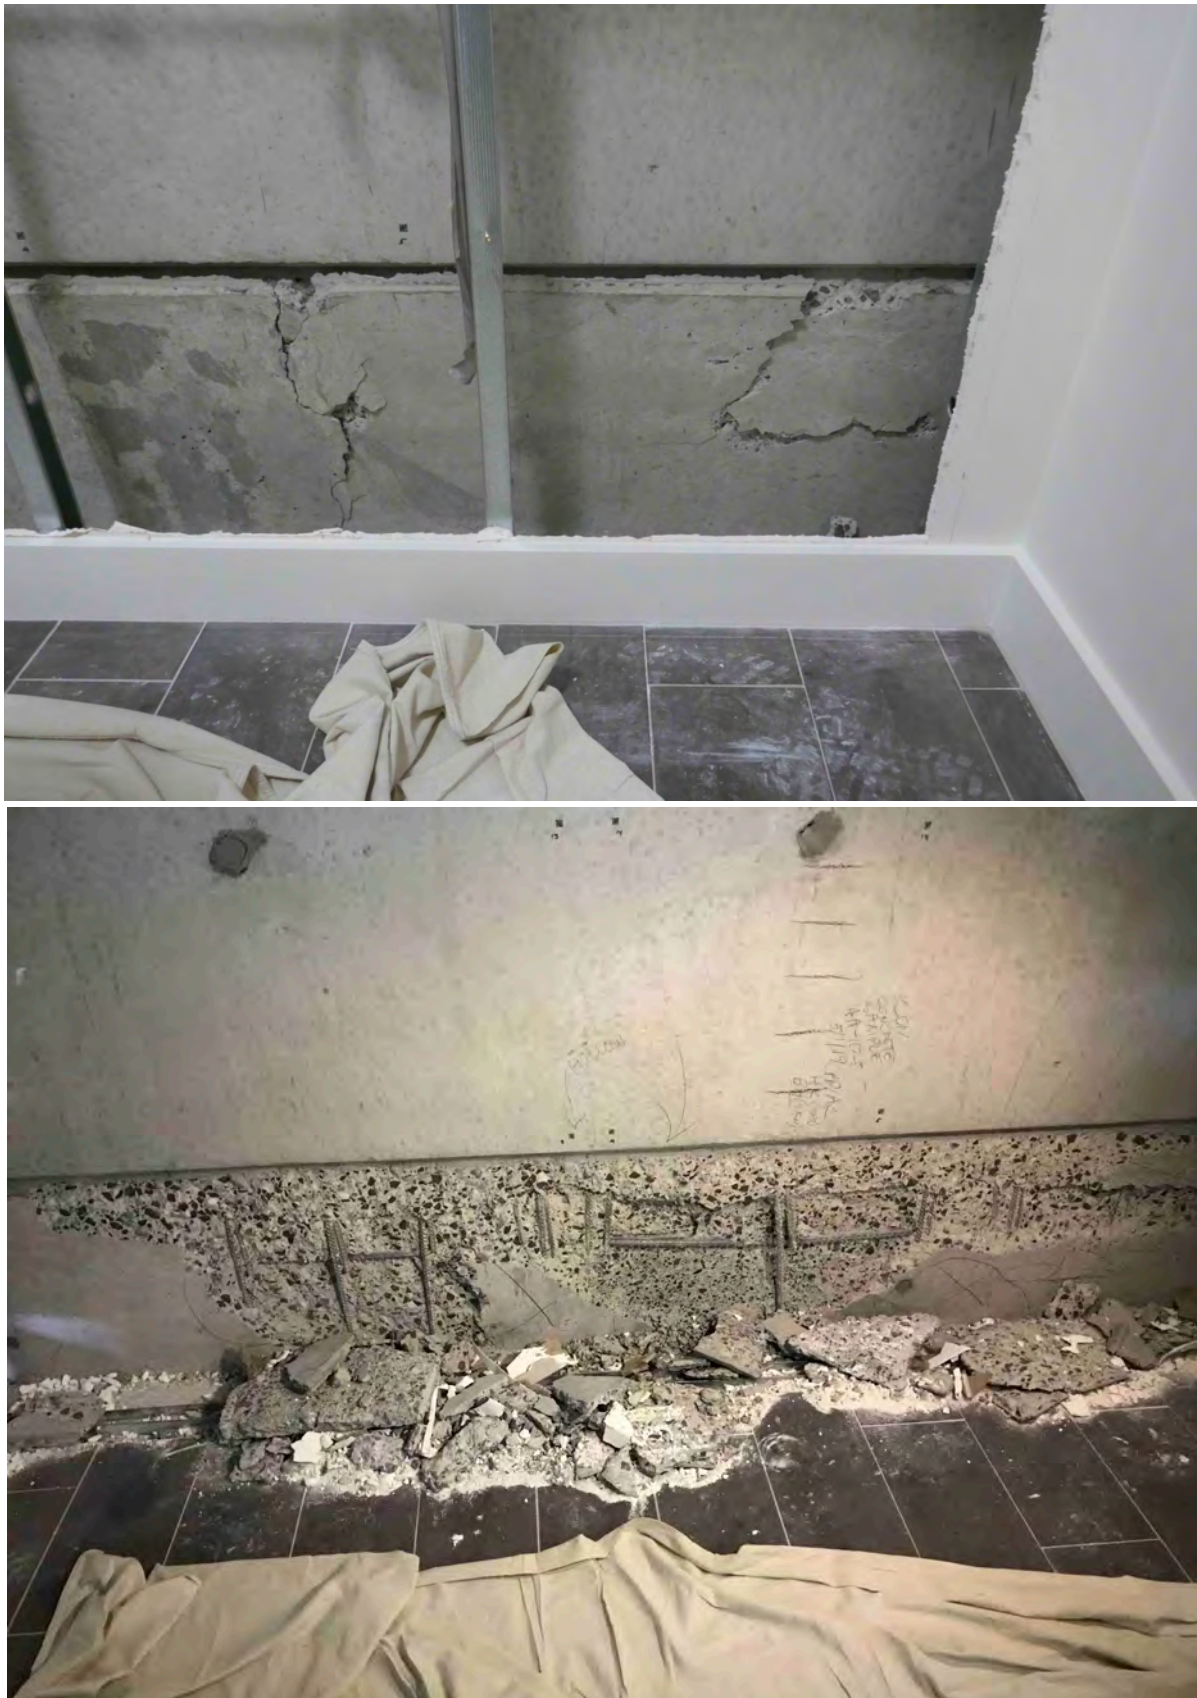
The architectural design where the major damage to the hob beam has been observed on Level 4 is quite different to that of the damaged hob beam on Level 10. Namely, the panels commencing at Level 4 are manufactured in two sections, rather than one, and the width of the hob beam is 320 mm under the inner panel and 180 mm under the outer panel.

The cause of the damage observed on Level 4 is still being assessed and the bearing of the damaged hob beam on its supporting columns is being studied in detail.

Figure 10. Photographs of the damaged hob beam on Level 4 near column C34 before (top) and after (bottom) cracked concrete removed.

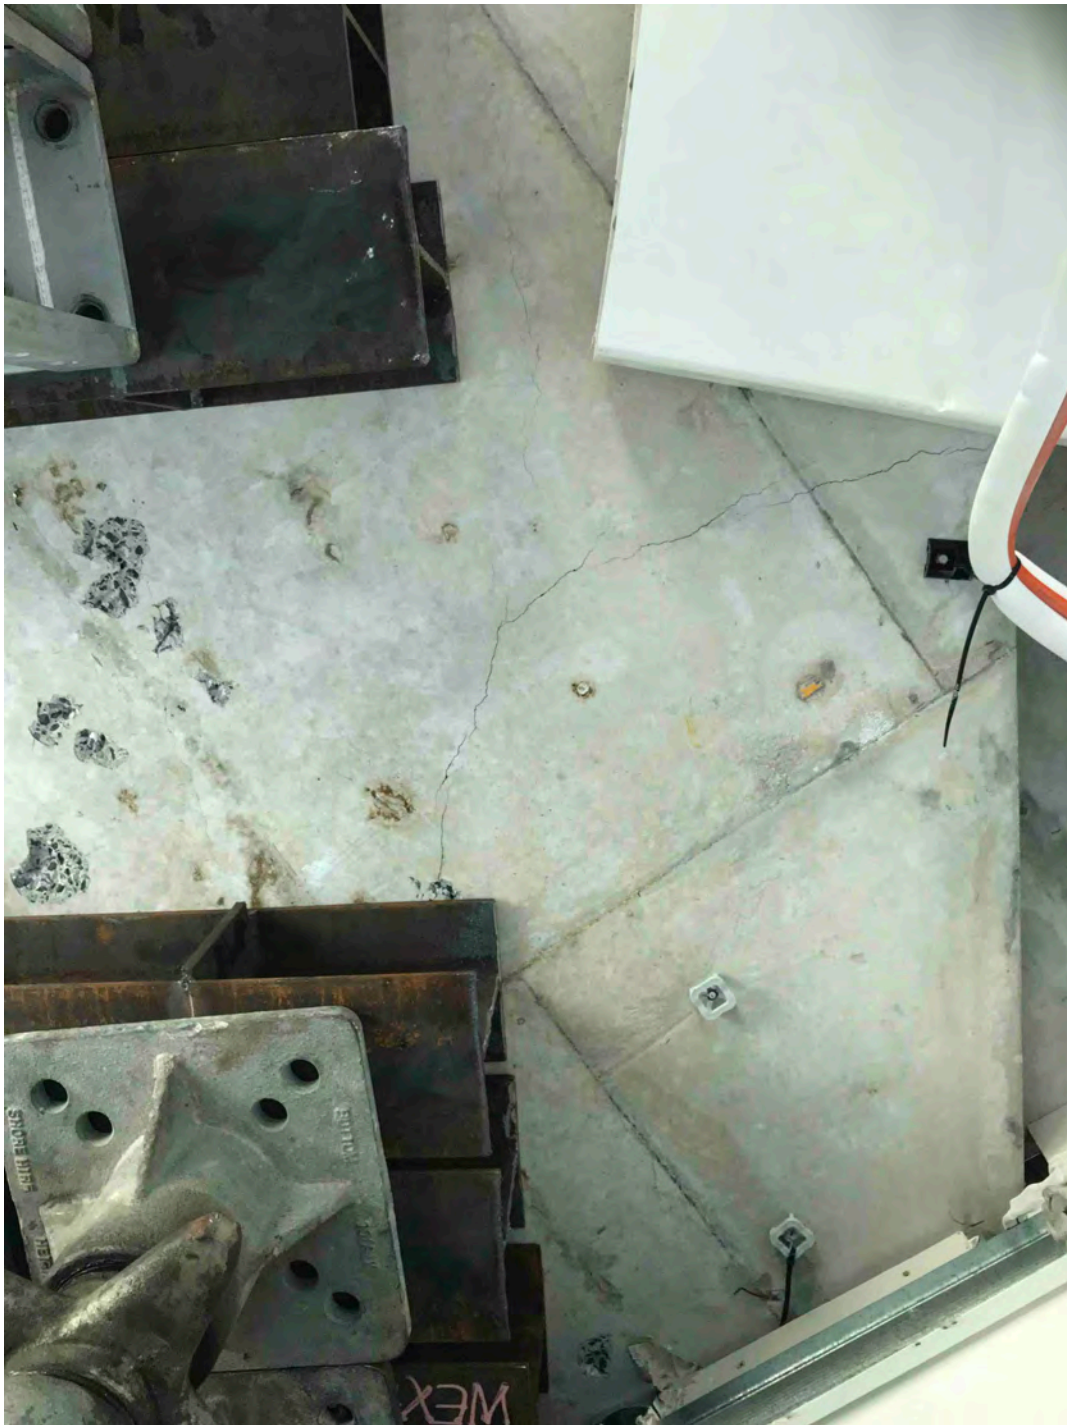
Figure 11. Photograph of a crack in the floor plate between Levels 3 and 4.
