OPAL TOWER INVESTIGATION INTERIM REPORT

**Independent Advice to NSW Minister for Planning and
Housing**

14 January 2019

OPAL TOWER INVESTIGATION – INTERIM REPORT

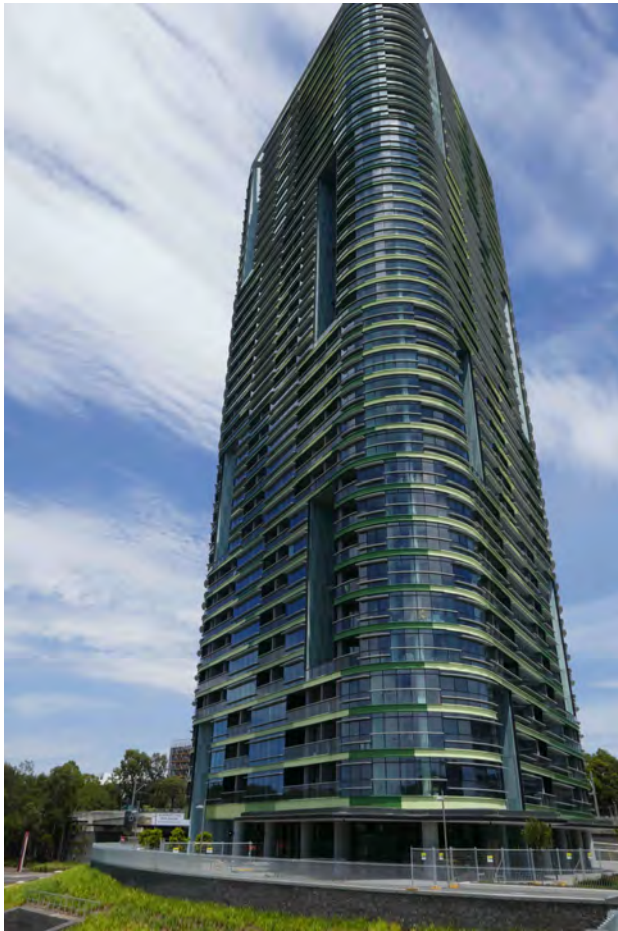
Figure 1. General view of the Opal Tower. Note the inset slots on the external faces of the building, each extending for multiple storeys (some 6 and others 10 storeys).

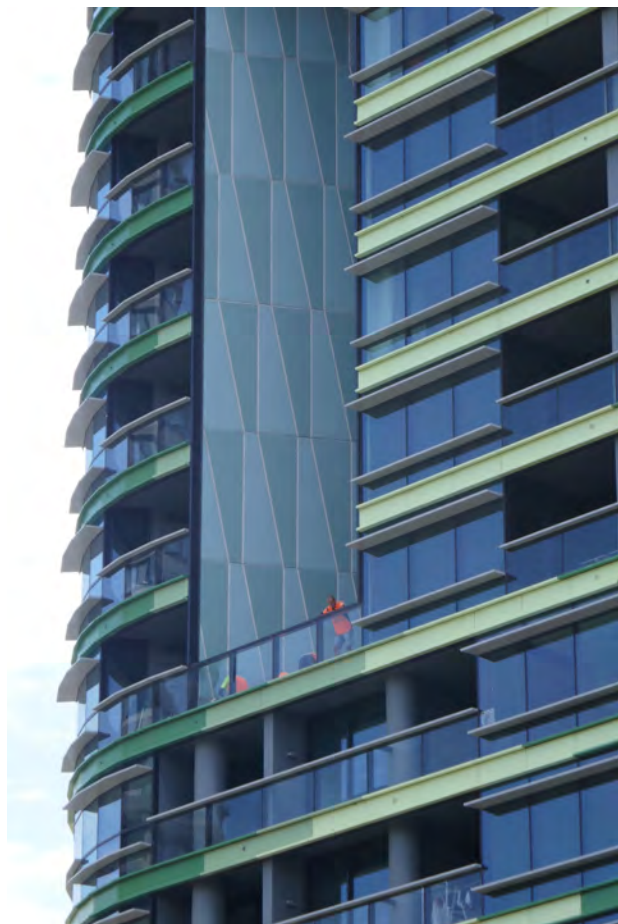
Figure 2. Close-up view of a 6 storey slot. Note the 6 panels forming the load bearing wall of the inset slot, each one storey high.
